# Manhole Inspection Summary

Manhole # S37AA1016MH

**Location** Address: **423 SOUTHWAY**

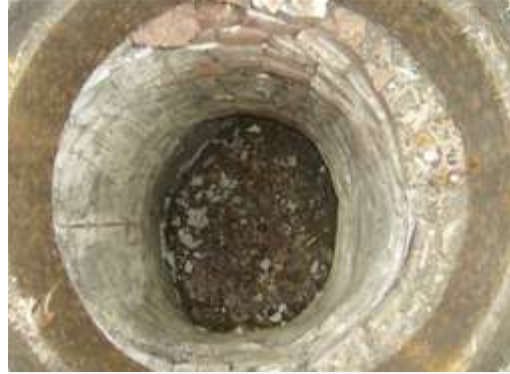
Top View

Channel debris.

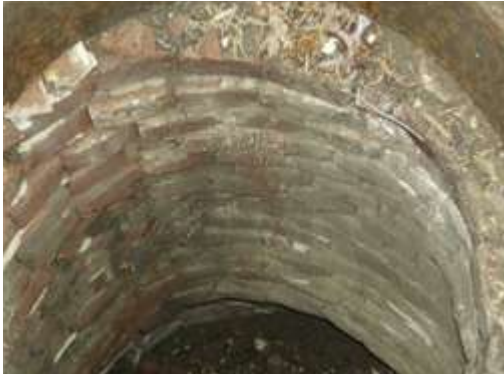
Defect

Offset: **4** (in.)

Condition: ☐ Sound ☐ Cracked ☐ Root Intrusion ☐ Loose Brick ☒ **Deteriorated**

Infiltration: ☐ None ☒ **Joint** ☐ Cracks ☐ Mortar ☐ Roots ☒ **Wall**

Frame offset. Adjustment deterioration and infiltration.

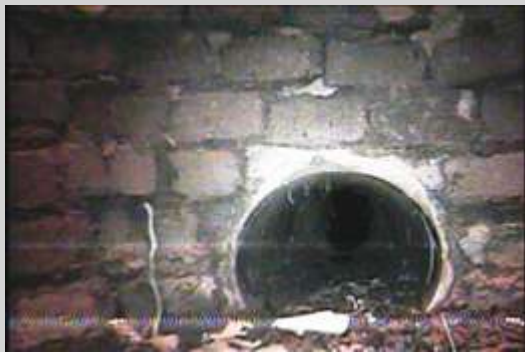
8 in. Circular Gravity Sewer  
Pipe Out @ 12 O'Clock

Condition: ☐ Sound ☐ Cracked ☒ **Root Intrusion** ☐ Loose Brick ☒ **Deteriorated**

Infiltration: ☐ None ☐ Joint ☐ Cracks ☒ **Mortar** ☒ **Roots** ☒ **Wall**

Barrel deterioration, root intrusion and infiltration.
